MILLTOWN POWER STATION DAM

ME 00217

PHASE I INSPECTION REPORT
NATIONAL DAM INSPECTION PROGRAM

Identification No. : ME 00217
Name of Dam : Milltown Power Station Dam
County & State : Washington, Maine
Date of Inspection : November 14, 1979

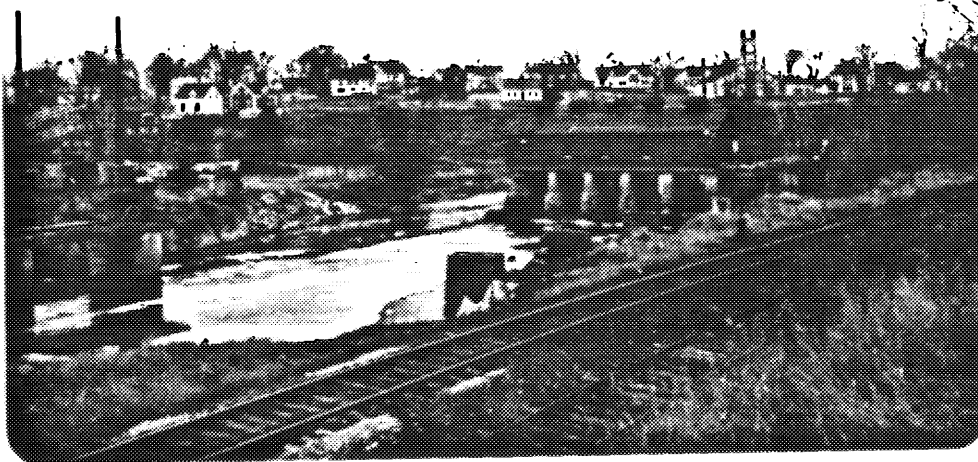
#1

View of the right side of the dam including the gatehouse (at right) and the rollway section (center).

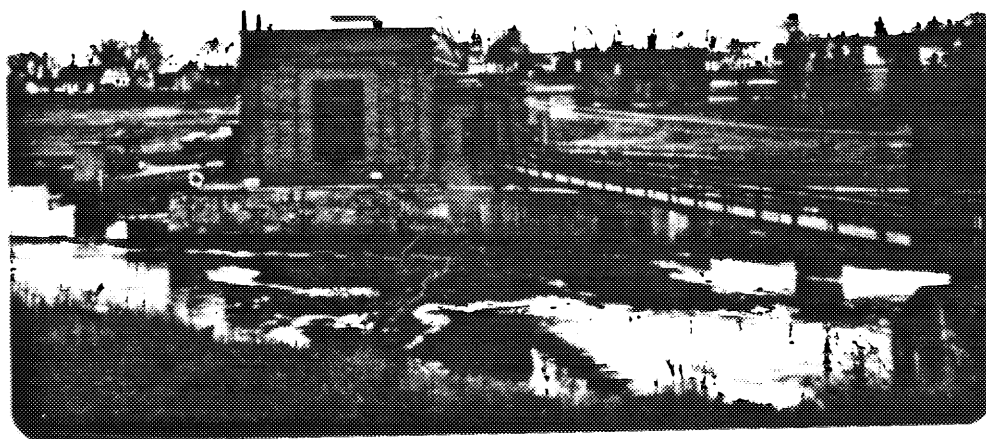
#2

View of powerhouse and pedestrian bridge from right bank.

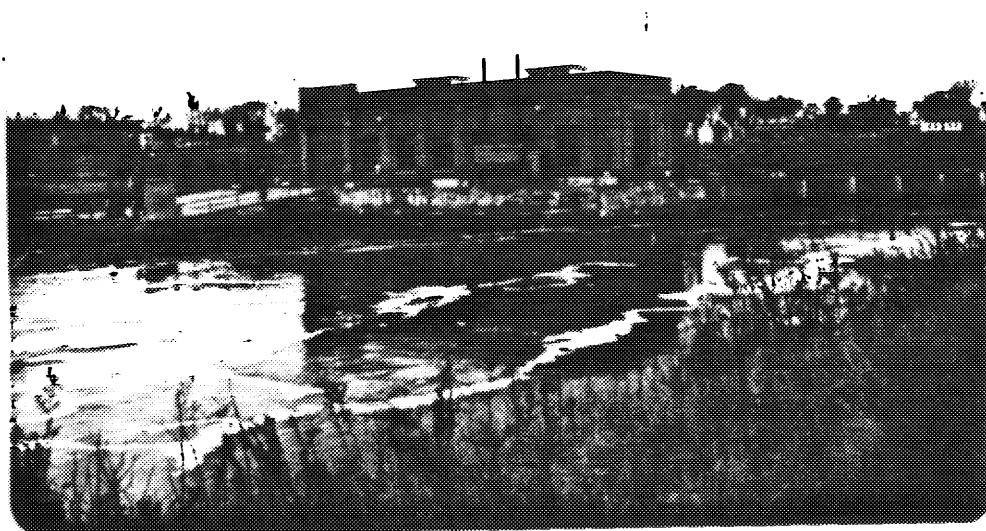
#3

View of powerhouse and stop-log gates at far right.
